**CASCADE BROOK DAM**

**NH 00082**

**PRELIMINARY INSPECTION REPORT  
NATIONAL DAM INSPECTION PROGRAM**

**DECEMBER 1980**

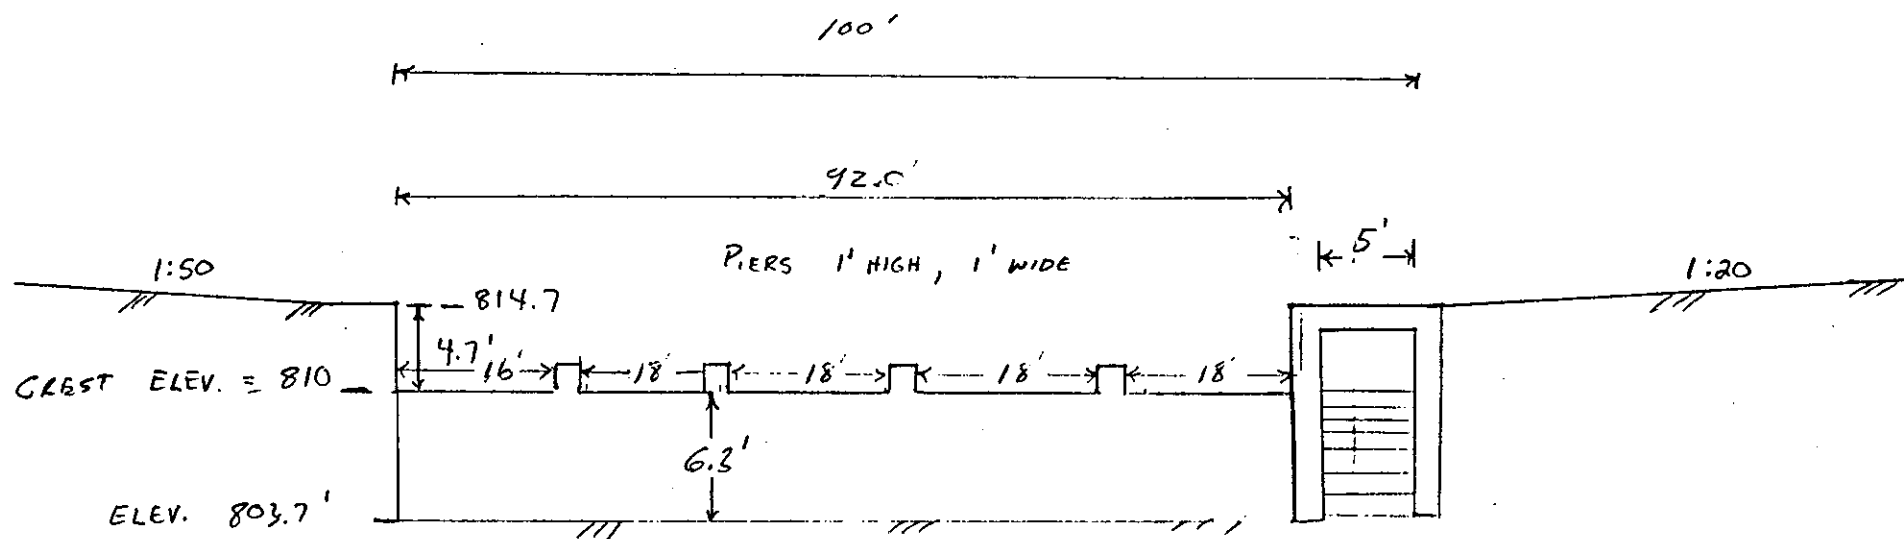
Assume that the dam fails at the top of the abutments 4.7' above the main spillway crest and 11' above the streambed. Also assume that the 1' piers will have a negligible affect on flow at this elevation.

BASED ON blue line plan sheet of Cascade Brook Dam.

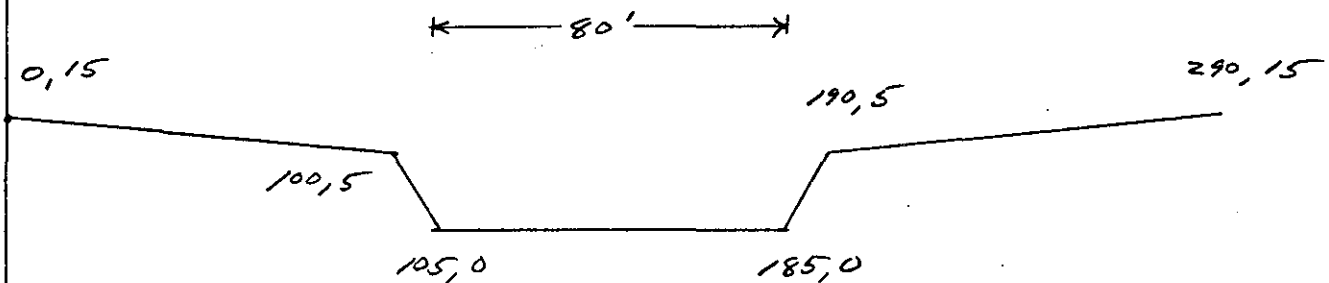
Downstream Cross section  
(NOT TO SCALE)

Main Channel  $n = .035$

Overbank  $n = .08$

From the rating table for this cross section, a failure flow of 4,412 cfs would create a stage of 8.0'. This is an increase of 1.2' over the normal outflow just prior to failure. (The normal outflow of 3,270 cfs corresponds to a stage of 6.8').
